# 6th Generation Intel® Processor Family

## Specification Update

*Supporting the 6th Generation Intel® Core™ Processor and Intel® Xeon® Processor Families based on the H-Platform*

*Supporting the Intel® Xeon® Processor E3-1200 v5 Product and Intel® Pentium® Processor Families based on the S-Platform*

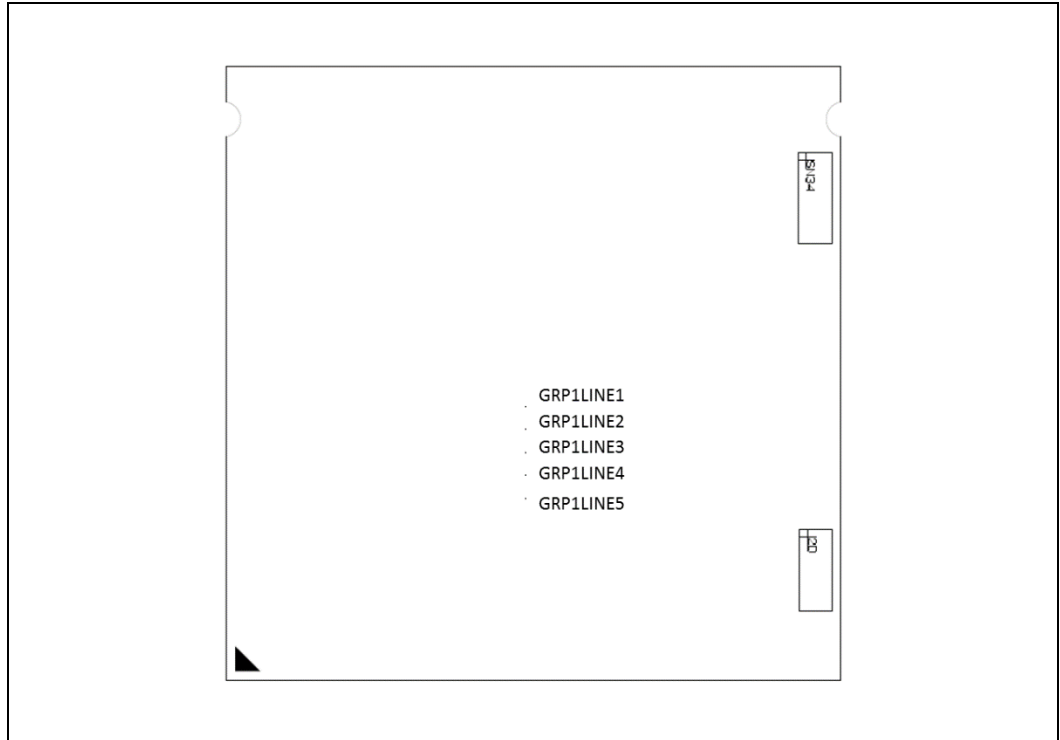
Figure 1. S-Processor Line LGA Top-Side Markings

Pin Count: 1151

Package Size: 37.5 mm x 37.5 mm
